Bear Walkway under construction after flood damage

Posted: Tuesday, Jul 20th, 2010

BY: BECKY CRUM, Herald Reporter

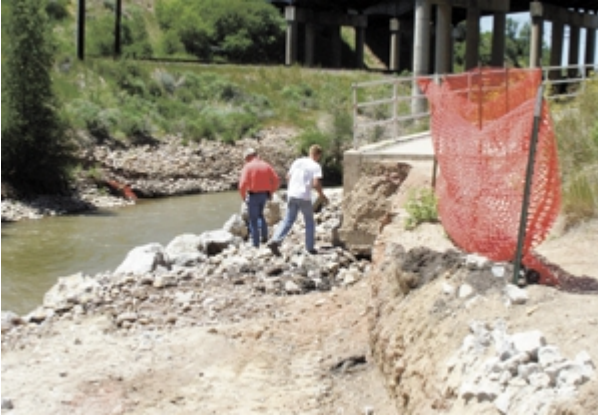
Evanston city work crews work diligently to repair extensive damage to sidewalks along the Bear River walkway, which was caused by spring runoff. HERALD PHOTO/Becky Crum

Rock wire encasings were filled with river cobble and placed south of the I-80 Bridge on the side of the river to protect the bank from being washed away.

"They call the wire encasings a rock mattress. They were placed along the river when they built the I-80 Bridge to keep the riverbank from washing out when the river rises. Some of those failed in the spot south of the freeway and it washed out underneath the mattresses. They rusted, causing the rock to fall out of the encasing," Honey said.

Honey explained that the rocks washed away leaving the bank exposed, and when the water rose, it washed away the bank as well.

“When the riverbank washed away, it undercut our trail we had constructed along the river. It was undercut so badly that we had to push the trail into the river because we couldn’t keep people off the path. They moved our barricades and walked right on down the trail even though it was hanging out in midair,” he said.

“In trying to limit the expense, and do the job as quickly as possible, I contacted the division director for the department of transportation, John Eddins in Rock Springs. He gave permission for us to get rock from the same pit in Kemmerer that we had used previously when we did phase II of the river restoration behind the Super 8 Hotel and Bear River Yamaha,” Honey said.

Honey said the area being replaced is a little more than 20 feet wide and 100 feet along the river and about 15 feet high. He said next week the city workers will start to redo the actual trail, restoring it so it can be put back in operation as soon as the concrete has time to cure.
