The calm after the storm

BY EVE NEWMAN / LBEDIT6@LARAMIEBOOMERANG.COM • WEDNESDAY, JUNE 30, 2010

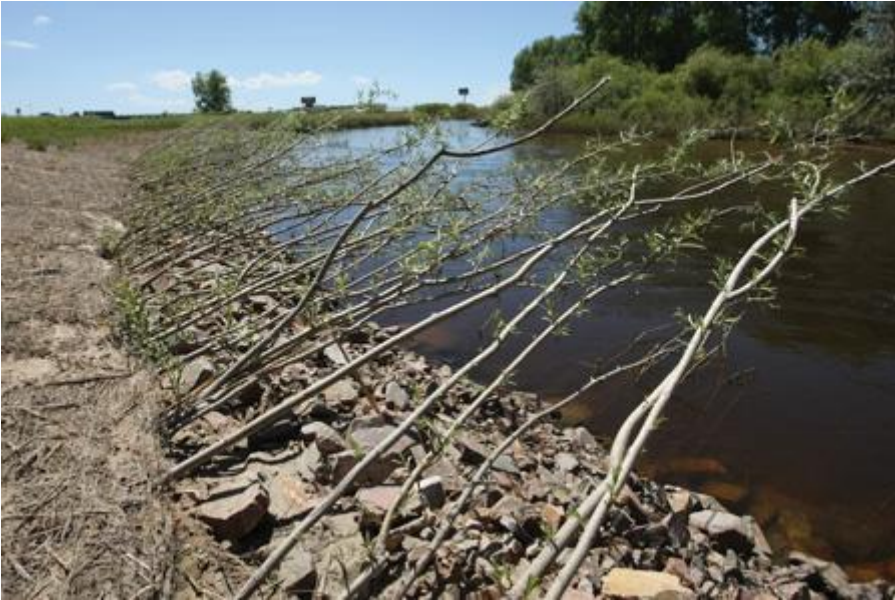
Willow trees planted by the Laramie Beautification Committee help prevent erosion along the Laramie River. Andy Carpenean/Boomerang photographer

Finally, willows were planted, facing toward the river at a low angle.

“The willows help to slow the water down as it comes over the top,” Tom Watson with Western Water Consultants said.

As floodwaters have receded, the willows are starting to show green leaves.
