# In-stream air stripper removes degreaser from local water supply

Warren Sentinel

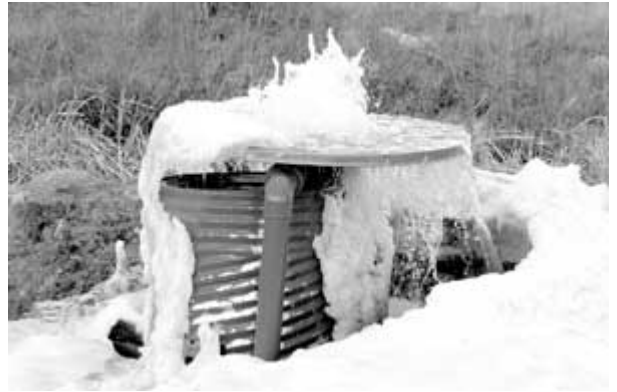
*The in-stream air stripper, located near Missile Dr. and South Creek Dr. The stripper cleans the water of a hazardous degreaser and sometimes emits water into the air. / Courtesy Photo*

The in-stream air stripper removes the TCE from the water by jetting air through the water, evaporating the TCE. Air pushes the water into the stripping tube and out on to a large metal plate where the water cascades off the plate and back into the stream. The system pumps air through the surface water from Diamond Creek and shallow groundwater found in the gravels directly below the streambed. No additional water is used, and all the water returns back to the stream so it continues downstream to Crow Creek. Volatile contaminants are further removed as water flows off the plate and back into the stream.
